Asbestos Pre-Demolition Survey Report

Job Ref No: **255768**, Account Ref No: **1095**, Contract Ref No: **33744**

John Frost School Lighthouse Rd, Duffryn, Newport NP10 8YD

Title: Demolition survey of John Frost School

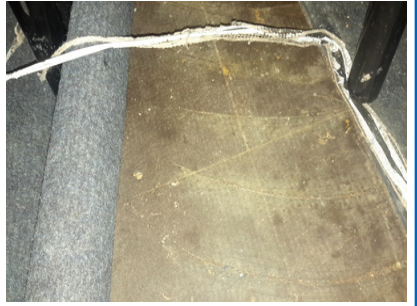
John Frost School Building 1	0	006/stairwell	Floor tiles	255768-54	Asbestos-containing floor tile with bitumen adhesive	Chrysotile	3	14 Sqm.	R3	Remove

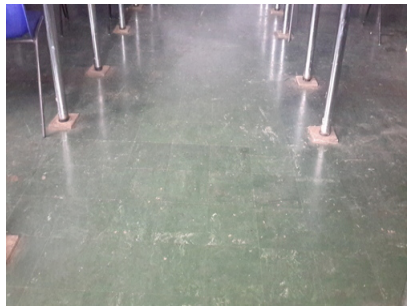
John Frost School Building 1	0	008/ corridor	Floor bitumen under screed	255768-73	Asbestos-containing bitumen adhesive	Chrysotile	3	30 Sqm.	R3	Remove

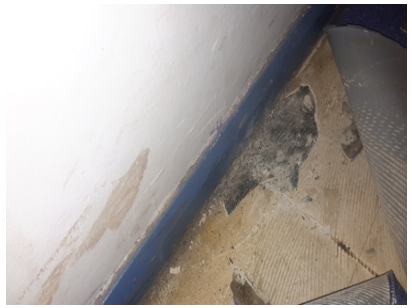
John Frost School Building 1	0	009/WC areas	Floor bitumen under screed	255768-73	Asbestos-containing bitumen adhesive	Chrysotile	3	30 Sqm.	R3	Remove

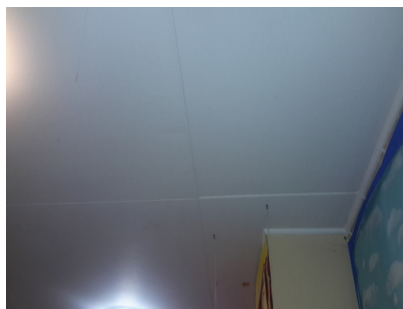
John Frost School Building 1	0	019/ corridor	Ceiling	255768-82	Asbestos-containing insulating board	Chrysotile, Amosite	6	30 Sqm.	R2	Remove

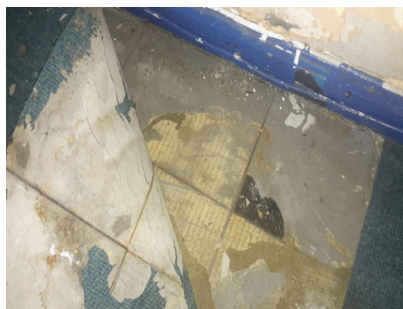
John Frost School Building 1	0	029/corridor	Floor tiles	255768-89	Asbestos-containing floor tile with bitumen adhesive	Chrysotile	3	20 Sqm.	R3	Remove

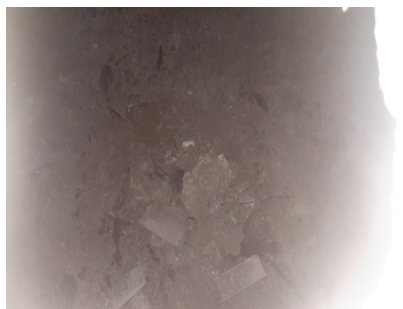
John Frost School Building 1	0	060/gym	Damp proof course to wall cavity under windows	255768-52	Asbestos-containing bituminous product	Chrysotile	4	6 Sqm.	R3	Remove

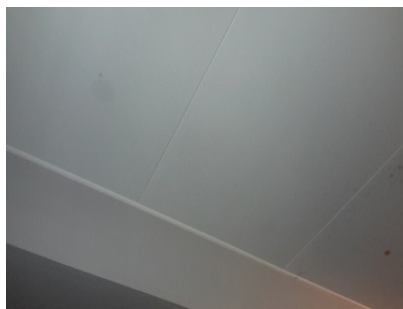
John Frost School Building 1	1	009/corridor	Ceiling	255768-28	Asbestos-containing insulating board	Amosite, Chrysotile	5	30 Sqm.	R3	Remove

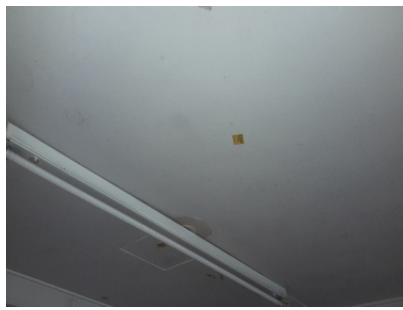
John Frost School Building 1	1	022/WC	Ceiling	255768-68	Asbestos-containing insulating board	Amosite, Chrysotile	5	4 Sqm.	R3	Remove

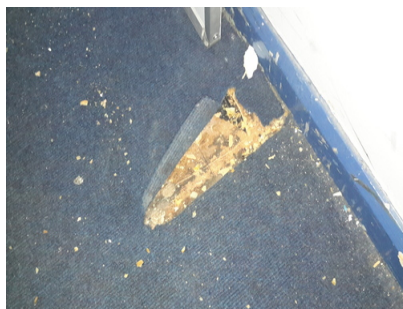
John Frost School Building 1	2	014/lobby	Large floor tiles	255768-19	Asbestos-containing floor tile with bitumen adhesive	Chrysotile	3	3 Sqm.	R3	Remove

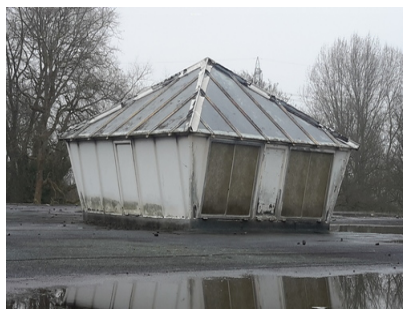
John Frost School Building 1	9	999/externals	Roof 1 skylight rope seal	255768-21	Asbestos-containing woven product	Chrysotile	6	5 Lm.	R3	Remove

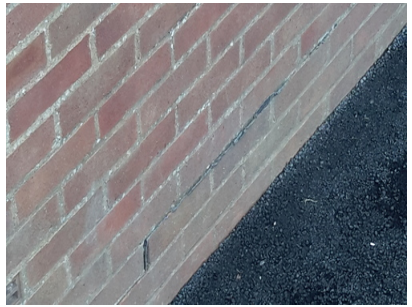
John Frost School Building 1	9	999/externals	Old window mastic	255768-62	Asbestos-containing mastic	Chrysotile	4	Throughout Location	R3	Remove
