Asbestos Pre-Demolition Survey Report

Job Ref No: **255768**, Account Ref No: **1095**, Contract Ref No: **33744**

John Frost School Lighthouse Rd, Duffryn, Newport NP10 8YD

Title: Demolition survey of John Frost School

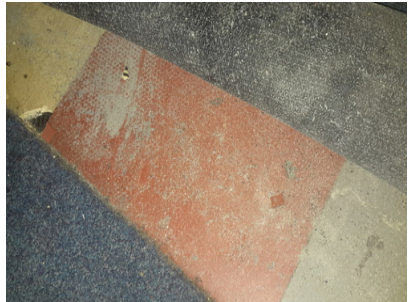
John Frost School Building 1	0	001/ staffroom	Floor tiles	255768-46	Asbestos-containing floor tile with bitumen adhesive	Chrysotile	3	30 Sqm.	R3	Remove

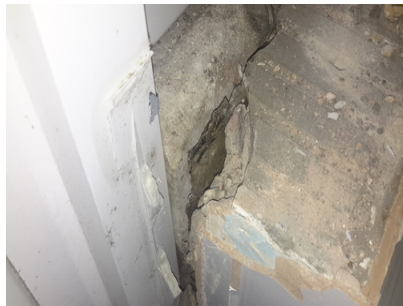
Building	Level	Location	Item / Product Examined	Sample No.	Material Description	Fibre Type	Material Score	Extent	Risk Level Assessment	Initial Control Recommendation	Photograph
John Frost School Building 1	0	002/ corridor	Damp proof course to wall cavity under windows	255768-52	Asbestos-containing bituminous product	Chrysotile	3	2 Sqm.	R3	Remove

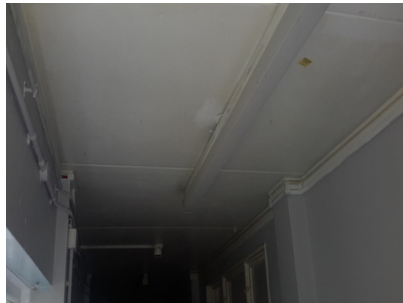
John Frost School Building 1	0	002/ corridor	Ceiling	255768-48	Asbestos-containing insulating board	Amosite, Chrysotile	5	20 Sqm.	R3	Remove

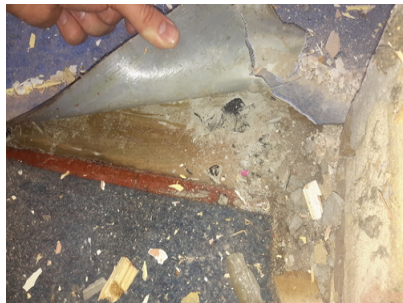
John Frost School Building 1	0	002/ corridor	Floor adhesive	255768-51	Asbestos-containing bitumen adhesive	Chrysotile	3	20 Sqm.	R3	Remove

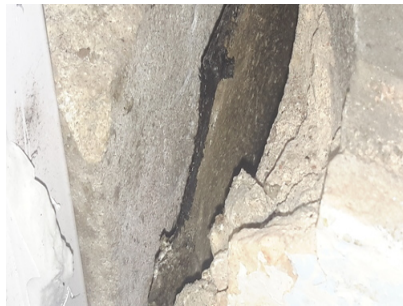
Building	Level	Location	Item / Product Examined	Sample No.	Material Description	Fibre Type	Material Score	Extent	Risk Level Assessment	Initial Control Recommendation	Photograph
John Frost School Building 1	0	003/office	Damp proof course to wall cavity under windows	255768-52	Asbestos-containing bituminous product	Chrysotile	3	3 Sqm.	R3	Remove

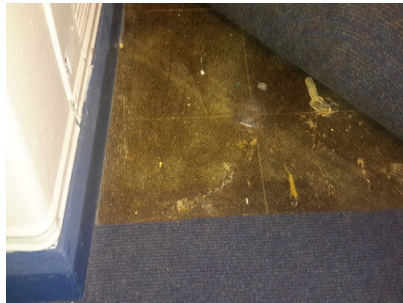
John Frost School Building 1	0	003/office	Floor tiles	255768-53	Asbestos-containing floor tile with bitumen adhesive	Chrysotile	3	12 Sqm.	R3	Remove

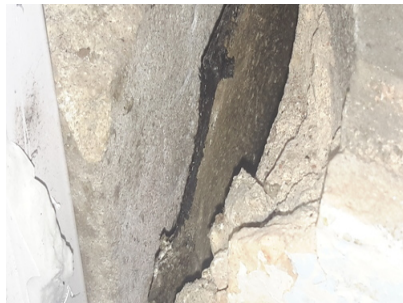
John Frost School Building 1	0	004/office	Damp proof course to wall cavity under windows	255768-52	Asbestos-containing bituminous product	Chrysotile	3	6 Sqm.	R3	Remove

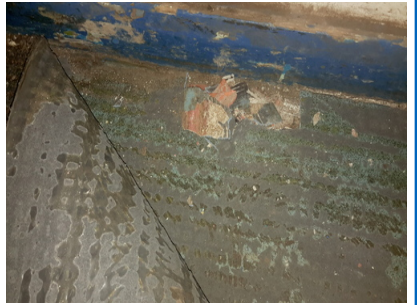
John Frost School Building 1	0	006/stairwell	Floor tiles	255768-54	Asbestos-containing floor tile with bitumen adhesive	Chrysotile	3	14 Sqm.	R3	Remove

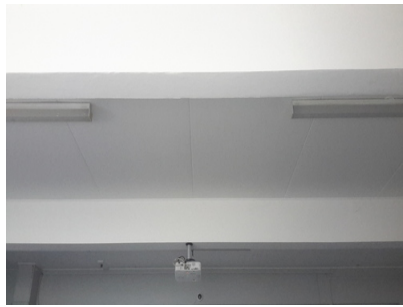
John Frost School Building 1	0	007/ classroom	Ceiling	255768-48	Asbestos-containing insulating board	Amosite, Chrysotile	5	60 Sqm.	R3	Remove

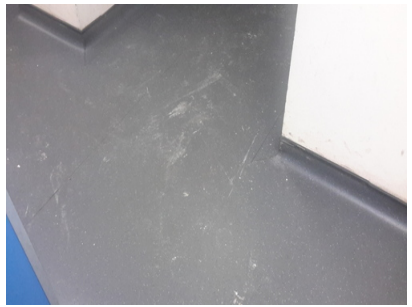
John Frost School Building 1	0	009/WC areas	Floor bitumen under screed	255768-73	Asbestos-containing bitumen adhesive	Chrysotile	3	30 Sqm.	R3	Remove

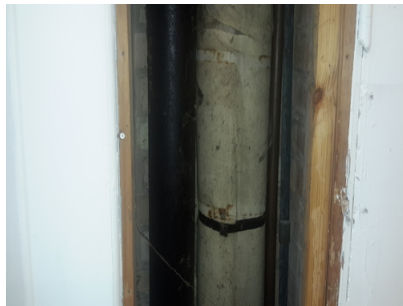
Building	Level	Location	Item / Product Examined	Sample No.	Material Description	Fibre Type	Material Score	Extent	Risk Level Assessment	Initial Control Recommendation	Photograph
John Frost School Building 1	0	010/ classroom	Vertical boxing pipework insulation lining	255768-35	Asbestos-containing paper	Chrysotile	6	6 Lm.	R3	Remove

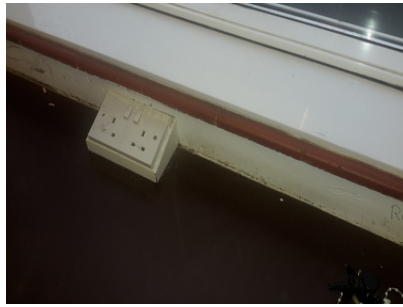
John Frost School Building 1	0	010/ classroom	Damp proof course to wall cavity under windows	255768-52	Asbestos-containing bituminous product	Chrysotile	3	8 Sqm.	R3	Remove

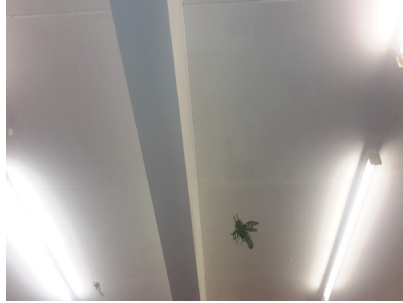
John Frost School Building 1	0	010/ classroom	Ceiling	255768-48	Asbestos-containing insulating board	Amosite, Chrysotile	5	60 Sqm.	R3	Remove

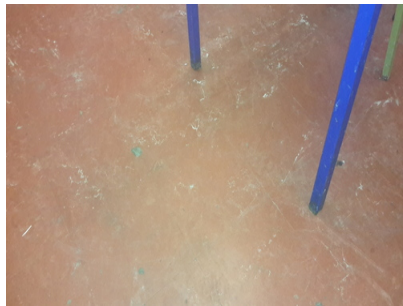
Building	Level	Location	Item / Product Examined	Sample No.	Material Description	Fibre Type	Material Score	Extent	Risk Level Assessment	Initial Control Recommendation	Photograph
John Frost School Building 1	0	010/ classroom	Floor tiles	255768-74	Asbestos-containing floor tile with bitumen adhesive	Chrysotile	3	60 Sqm.	R3	Remove

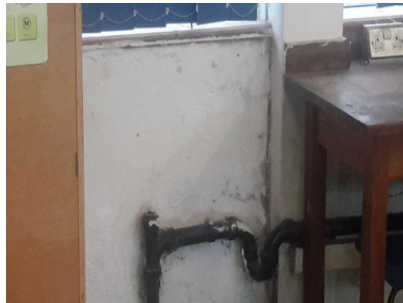
John Frost School Building 1	0	011/ classroom	Damp proof course to wall cavity under windows	255768-52	Asbestos-containing bituminous product	Chrysotile	3	8 Sqm.	R3	Remove

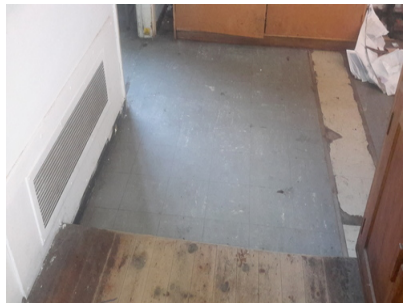
John Frost School Building 1	0	011/ classroom	Floor tiles	255768-78	Asbestos-containing floor tile with bitumen adhesive	Chrysotile	3	60 Sqm.	R3	Remove

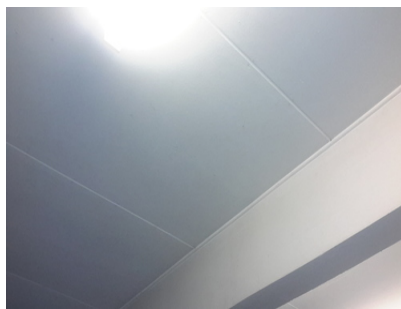
Building	Level	Location	Item / Product Examined	Sample No.	Material Description	Fibre Type	Material Score	Extent	Risk Level Assessment	Initial Control Recommendation	Photograph
John Frost School Building 1	0	011/classroom	Ceiling	255768-48	Asbestos-containing insulating board	Amosite, Chrysotile	5	60 Sqm.	R3	Remove

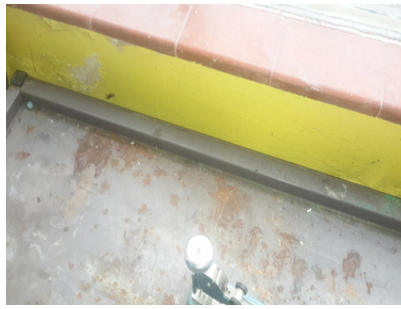
John Frost School Building 1	0	012/store	Damp proof course to wall cavity under windows	255768-52	Asbestos-containing bituminous product	Chrysotile	3	3 Sqm.	R3	Remove

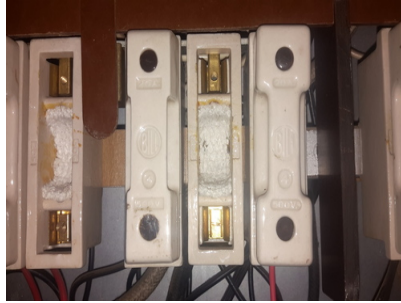
John Frost School Building 1	0	012/store	Flash guard to fusebox	255768-39	Asbestos-containing woven product	Chrysotile	6	18 Sqm.	R3	Remove

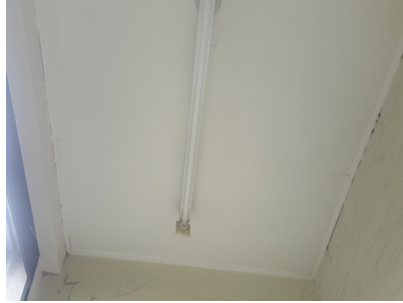
John Frost School Building 1	0	013/store	Ceiling	255768-48	Asbestos-containing insulating board	Amosite, Chrysotile	5	4 Sqm.	R3	Remove

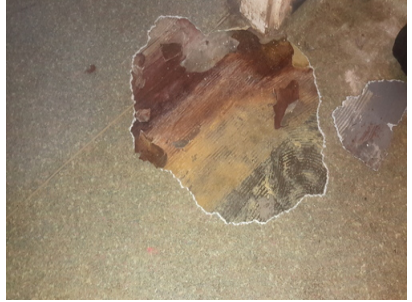
John Frost School Building 1	0	015/cupboard	Floor bitumen	255768-73	Asbestos-containing bitumen adhesive	Chrysotile	3	1 Sqm.	R3	Remove

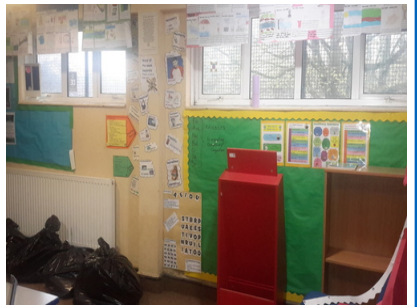
John Frost School Building 1	0	017/classroom	Damp proof course to wall cavity under windows	255768-52	Asbestos-containing bituminous product	Chrysotile	3	8 Sqm.	R3	Remove

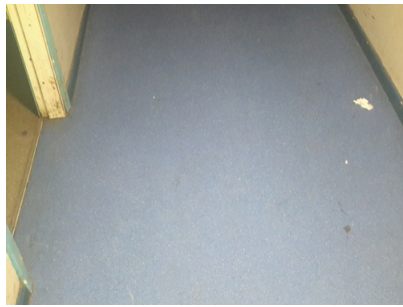
John Frost School Building 1	0	019/ corridor	Floor bitumen under screed	255768-73	Asbestos-containing bitumen adhesive	Chrysotile	3	30 Sqm.	R3	Remove

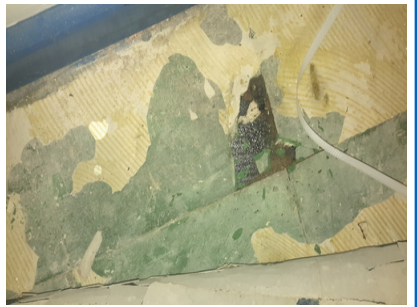
John Frost School Building 1	0	020/office	Floor tiles	255768-83	Asbestos-containing floor tile with bitumen adhesive	Chrysotile	3	8 Sqm.	R3	Remove

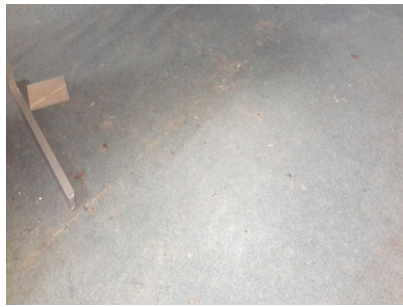
John Frost School Building 1	0	021/ classroom	Floor tiles	255768-83	Asbestos-containing floor tile with bitumen adhesive	Chrysotile	3	12 Sqm.	R3	Remove

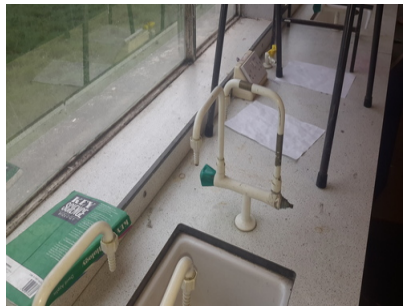
Building	Level	Location	Item / Product Examined	Sample No.	Material Description	Fibre Type	Material Score	Extent	Risk Level Assessment	Initial Control Recommendation	Photograph
John Frost School Building 1	0	022/ classroom	Damp proof course to wall cavity under windows	255768-52	Asbestos-containing bituminous product	Chrysotile	4	8 Sqm.	R3	Remove

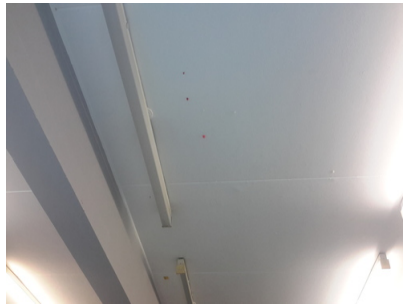
John Frost School Building 1	0	022/ classroom	Ceiling	255768-82	Asbestos-containing insulating board	Chrysotile, Amosite	5	60 Sqm.	R3	Remove

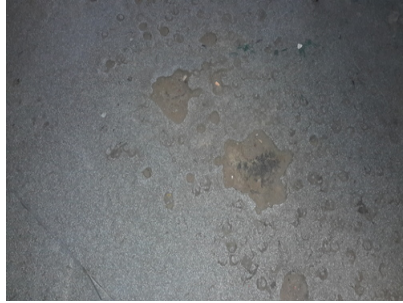
John Frost School Building 1	0	022/ classroom	Floor adhesive	255768-73	Asbestos-containing bitumen adhesive	Chrysotile	3	60 Sqm.	R3	Remove

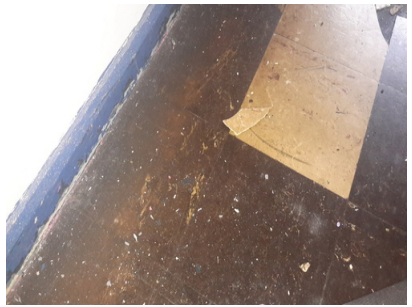
John Frost School Building 1	0	023/ classroom	Floor tiles	255768-84	Asbestos-containing floor tile with bitumen adhesive	Chrysotile	3	60 Sqm.	R3	Remove

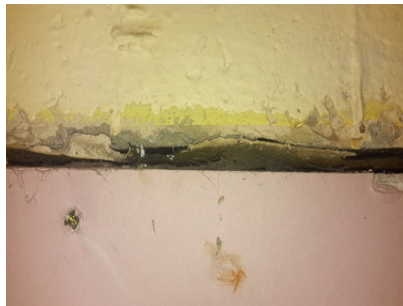
Building	Level	Location	Item / Product Examined	Sample No.	Material Description	Fibre Type	Material Score	Extent	Risk Level Assessment	Initial Control Recommendation	Photograph
John Frost School Building 1	0	024/store	Damp proof course over door	255768-85	Asbestos-containing bituminous product	Chrysotile	3	1 Lm.	R3	Remove

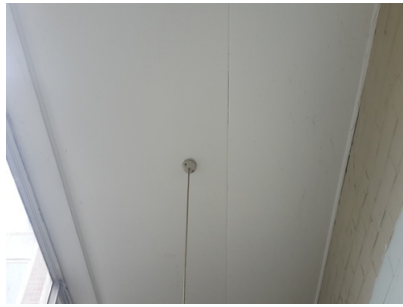
John Frost School Building 1	0	025/store	Ceiling	255768-82	Asbestos-containing insulating board	Chrysotile, Amosite	5	4 Sqm.	R3	Remove

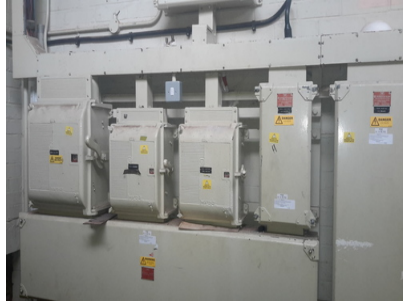
John Frost School Building 1	0	026/electrics room	Flashguards to fuse boxes	255768-39	Asbestos-containing woven product	Chrysotile	6	Throughout Location	R3	Remove

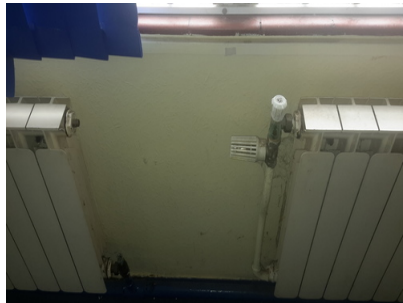
John Frost School Building 1	0	028/office	Damp proof course to wall cavity under windows	255768-52	Asbestos-containing bituminous product	Chrysotile	3	4 Sqm.	R3	Remove

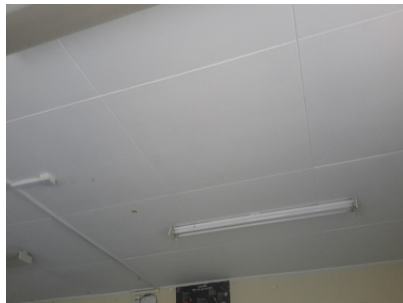
John Frost School Building 1	0	028/office	Ceiling	255768-82	Asbestos-containing insulating board	Chrysotile, Amosite	5	40 Sqm.	R3	Remove

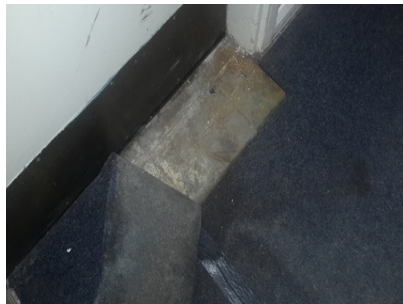
John Frost School Building 1	0	029/corridor	Floor tiles	255768-89	Asbestos-containing floor tile with bitumen adhesive	Chrysotile	3	20 Sqm.	R3	Remove

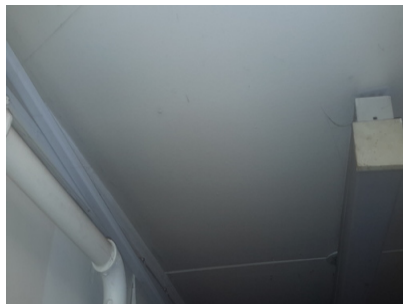
John Frost School Building 1	0	029/corridor	Ceiling	255768-82	Asbestos-containing insulating board	Chrysotile, Amosite	5	20 Sqm.	R3	Remove

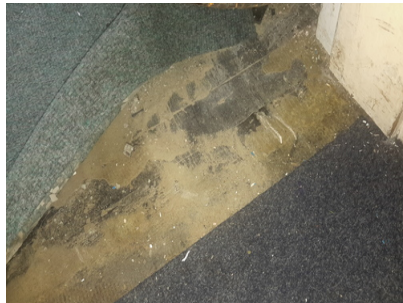
John Frost School Building 1	0	030/office	Floor tiles	255768-90	Asbestos-containing floor tile with bitumen adhesive	Chrysotile	3	6 Sqm.	R3	Remove

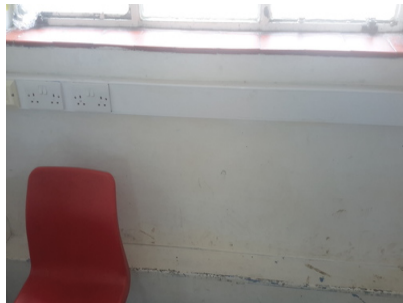
John Frost School Building 1	0	030/office	Damp proof course to wall cavity under windows	255768-52	Asbestos-containing bituminous product	Chrysotile	3	2 Sqm.	R3	Remove

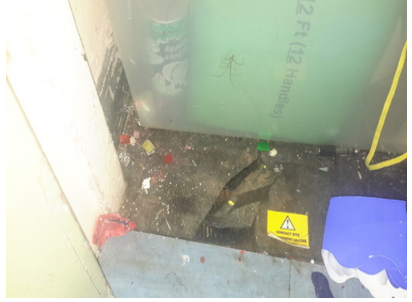
John Frost School Building 1	0	031/ kitchen	Cupboard floor tiles	255768-93	Asbestos-containing floor tile with bitumen adhesive	Chrysotile	3	1 Sqm.	R3	Remove

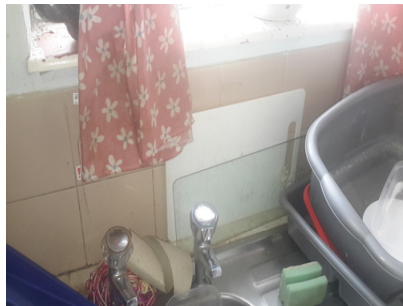
Building	Level	Location	Item / Product Examined	Sample No.	Material Description	Fibre Type	Material Score	Extent	Risk Level Assessment	Initial Control Recommendation	Photograph
John Frost School Building 1	0	031/kitchen	Damp proof course to wall cavity under windows	255768-52	Asbestos-containing bituminous product	Chrysotile	3	1 Sqm.	R3	Remove

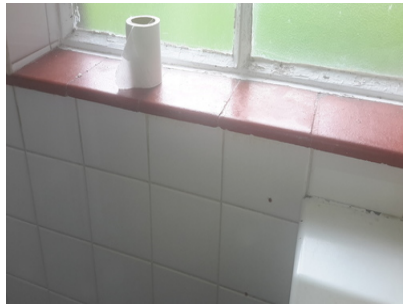
John Frost School Building 1	0	032/WC	Damp proof course to wall cavity under windows	255768-52	Asbestos-containing bituminous product	Chrysotile	3	2 Sqm.	R3	Remove

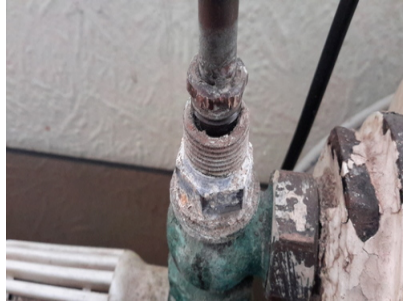
John Frost School Building 1	0	033/office	Rad valve wadding	255768-95	Asbestos-containing woven product	Chrysotile	6	1 No.	R3	Remove

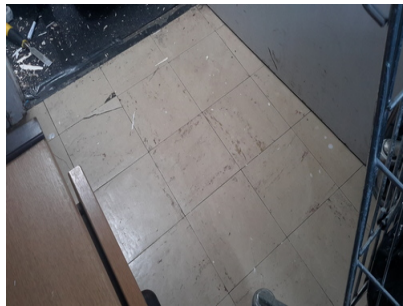
Building	Level	Location	Item / Product Examined	Sample No.	Material Description	Fibre Type	Material Score	Extent	Risk Level Assessment	Initial Control Recommendation	Photograph
John Frost School Building 1	0	033/office	Floor tiles	255768-94	Asbestos-containing floor tile with bitumen adhesive	Chrysotile	3	6 Sqm.	R3	Remove

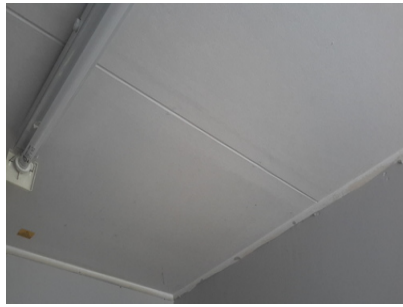
John Frost School Building 1	0	033/office	Ceiling	255768-82	Asbestos-containing insulating board	Chrysotile, Amosite	5	6 Sqm.	R3	Remove

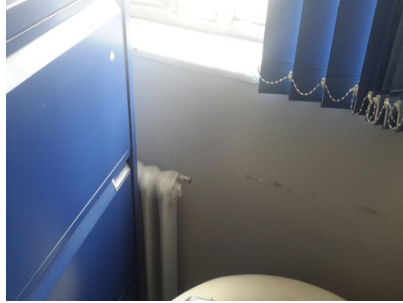
John Frost School Building 1	0	033/office	Damp proof course to wall cavity under windows	255768-52	Asbestos-containing bituminous product	Chrysotile	3	2 Sqm.	R3	Remove

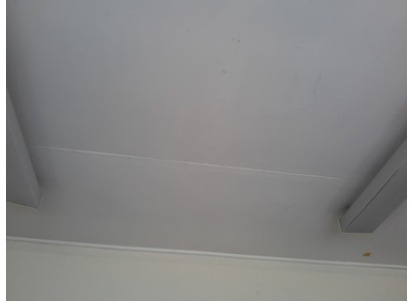
John Frost School Building 1	0	034/office	Ceiling	255768-82	Asbestos-containing insulating board	Chrysotile, Amosite	5	6 Sqm.	R3	Remove

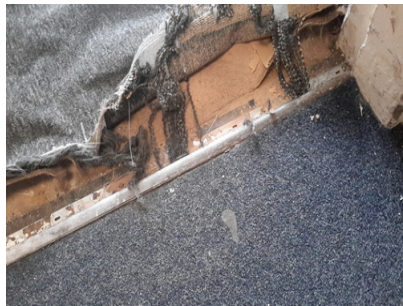
Building	Level	Location	Item / Product Examined	Sample No.	Material Description	Fibre Type	Material Score	Extent	Risk Level Assessment	Initial Control Recommendation	Photograph
John Frost School Building 1	0	034/office	Floor adhesive	255768-92	Asbestos-containing bitumen adhesive	Chrysotile	3	4 Sqm.	R3	Remove

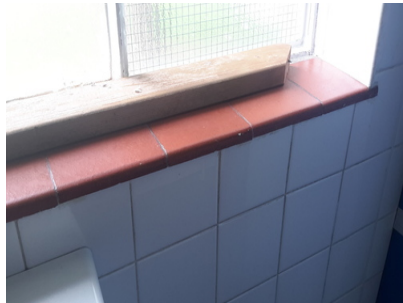
John Frost School Building 1	0	035/WC	Damp proof course to wall cavity under windows	255768-52	Asbestos-containing bituminous product	Chrysotile	3	2 Sqm.	R3	Remove

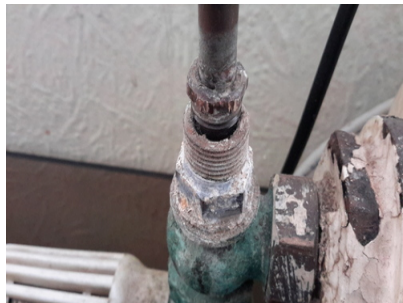
John Frost School Building 1	0	036/office	Rad valve wadding	255768-95	Asbestos-containing woven product	Chrysotile	6	1 No.	R3	Remove

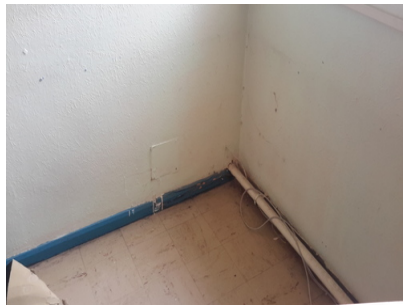
John Frost School Building 1	0	036/office	Floor tiles	255768-94	Asbestos-containing floor tile with bitumen adhesive	Chrysotile	3	8 Sqm.	R3	Remove

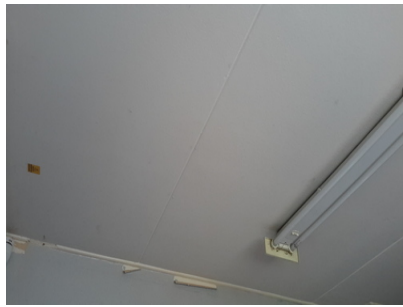
John Frost School Building 1	0	038/office	Ceiling	255768-82	Asbestos-containing insulating board	Chrysotile, Amosite	5	8 Sqm.	R3	Remove

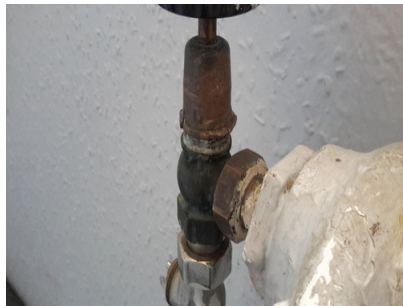
Building	Level	Location	Item / Product Examined	Sample No.	Material Description	Fibre Type	Material Score	Extent	Risk Level Assessment	Initial Control Recommendation	Photograph
John Frost School Building 1	0	038/office	Rad valve wadding	255768-95	Asbestos-containing woven product	Chrysotile	6	1 No.	R3	Remove

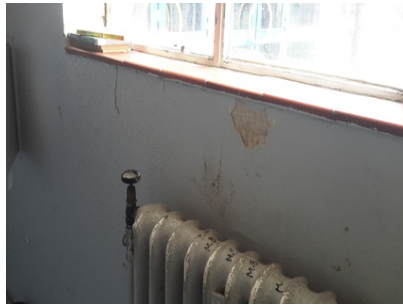
John Frost School Building 1	0	038/office	Damp proof course to wall cavity under windows	255768-52	Asbestos-containing bituminous product	Chrysotile	3	2 Sqm.	R3	Remove

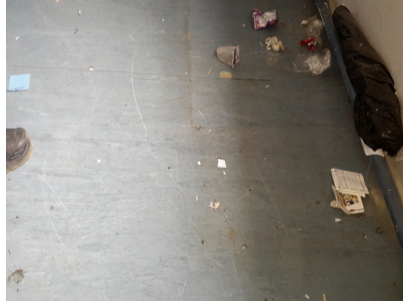
John Frost School Building 1	0	038/office	Floor adhesive	255768-94	Asbestos-containing bitumen adhesive	Chrysotile	3	8 Sqm.	R3	Remove

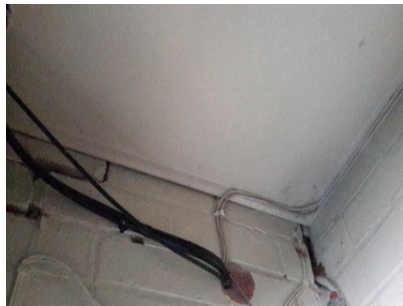
Building	Level	Location	Item / Product Examined	Sample No.	Material Description	Fibre Type	Material Score	Extent	Risk Level Assessment	Initial Control Recommendation	Photograph
John Frost School Building 1	0	039/ cupboard	Ceiling	255768-82	Asbestos-containing insulating board	Chrysotile, Amosite	5	1 Sqm.	R3	Remove

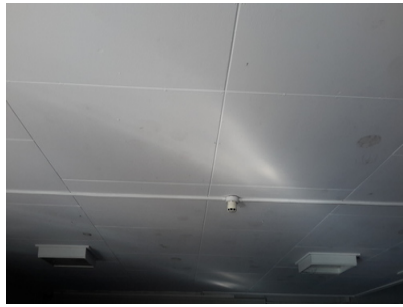
John Frost School Building 1	0	040/ entrance hall	Ceiling	255768-82	Asbestos-containing insulating board	Chrysotile, Amosite	5	50 Sqm.	R3	Remove

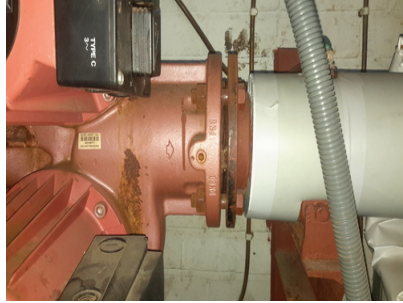
John Frost School Building 1	0	041/plant room	Pipework gaskets	255768-98	Asbestos-containing gasket	Chrysotile	5	20 No.	R3	Remove

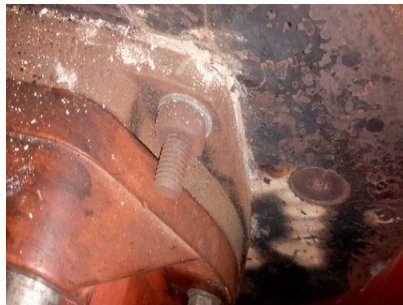
Building	Level	Location	Item / Product Examined	Sample No.	Material Description	Fibre Type	Material Score	Extent	Risk Level Assessment	Initial Control Recommendation	Photograph
John Frost School Building 1	0	041/plant room	Gaskets to front of boiler	255768-100	Asbestos-containing gaskets	Chrysotile	5	2 No.	R3	Remove

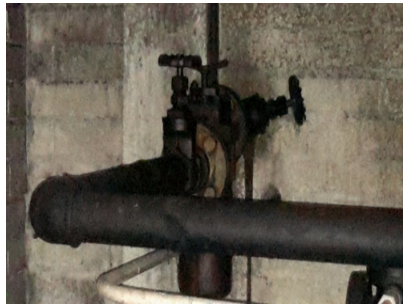
John Frost School Building 1	0	042/tank room	Pipework gaskets	255768-98	Asbestos-containing gasket	Chrysotile	5	2 No.	R3	Remove

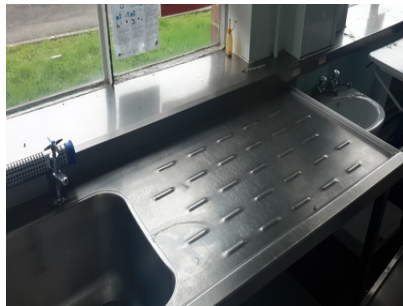
Building	Level	Location	Item / Product Examined	Sample No.	Material Description	Fibre Type	Material Score	Extent	Risk Level Assessment	Initial Control Recommendation	Photograph
John Frost School Building 1	0	044/kitchen	Damp proof course to wall cavity under windows	255768-52	Asbestos-containing bituminous product	Chrysotile	3	12 Sqm.	R3	Remove

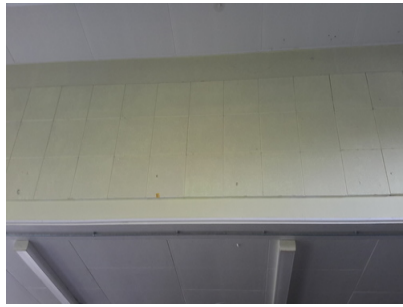
John Frost School Building 1	0	049/hall	Acoustic wall tiles	255768-103	Asbestos-containing insulating board	Chrysotile, Amosite	6	20 Sqm.	R3	Remove

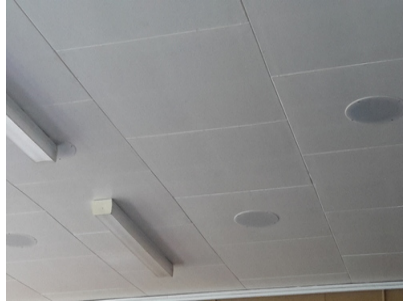
John Frost School Building 1	0	049/hall	Ceiling	255768-82	Asbestos-containing insulating board	Chrysotile, Amosite	5	100 Sqm.	R3	Remove

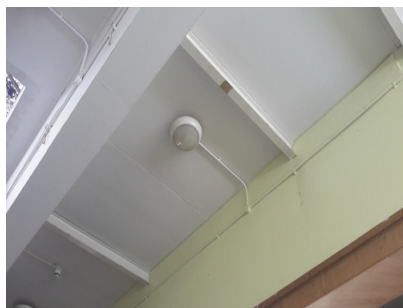
Building	Level	Location	Item / Product Examined	Sample No.	Material Description	Fibre Type	Material Score	Extent	Risk Level Assessment	Initial Control Recommendation	Photograph
John Frost School Building 1	0	050/stage & corridor	Ceiling	255768-82	Asbestos-containing insulating board	Chrysotile, Amosite	5	40 Sqm.	R3	Remove

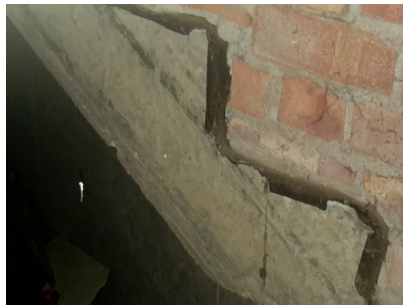
John Frost School Building 1	0	050/stage & corridor	Damp proof course under stage steps	255768-104	Asbestos-containing bituminous product	Chrysotile	4	4 Lm.	R3	Remove

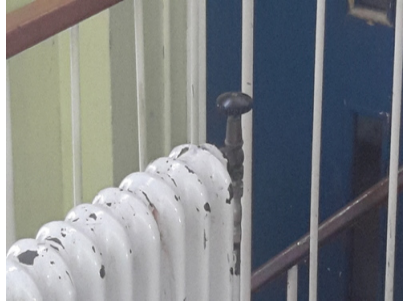
John Frost School Building 1	0	050/stage & corridor	Rad valve wadding	255768-95	Asbestos-containing woven product	Chrysotile	6	2 No.	R3	Remove

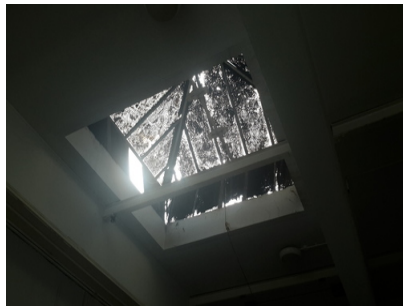
Building	Level	Location	Item / Product Examined	Sample No.	Material Description	Fibre Type	Material Score	Extent	Risk Level Assessment	Initial Control Recommendation	Photograph
John Frost School Building 1	0	050/stage & corridor	Skylight rope seal	255768-21	Asbestos-containing woven product	Chrysotile	7	5 Sqm.	R2	Remove

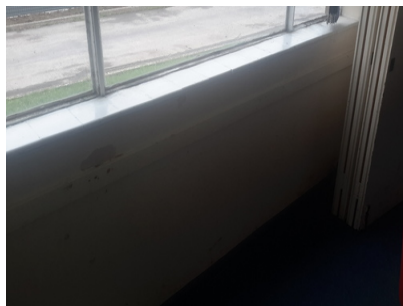
John Frost School Building 1	0	053/classroom	Damp proof course to wall cavity under windows	255768-52	Asbestos-containing bituminous product	Chrysotile	3	6 Sqm.	R3	Remove

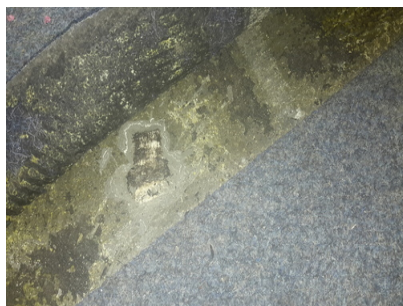
John Frost School Building 1	0	053/classroom	Floor adhesive	255768-105	Asbestos-containing bitumen adhesive	Chrysotile	4	30 Sqm.	R3	Remove

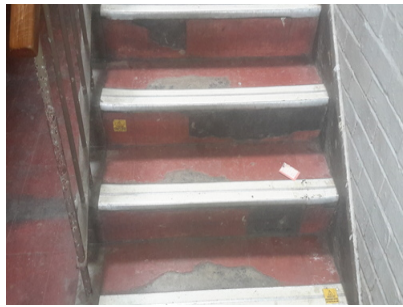
John Frost School Building 1	0	054/ stairwell	Stair tread tiles	255768-106	Asbestos-containing floor tile with bitumen adhesive	Chrysotile	3	5 Sqm.	R3	Remove

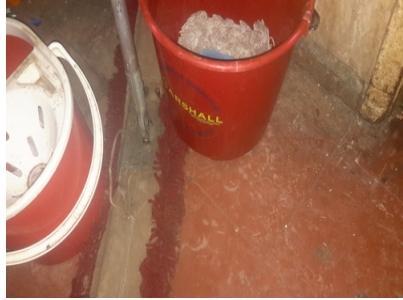
John Frost School Building 1	0	055/ cleaners cupboard	Floor tiles	255768-106	Asbestos-containing floor tile with bitumen adhesive	Chrysotile	3	2 Sqm.	R3	Remove

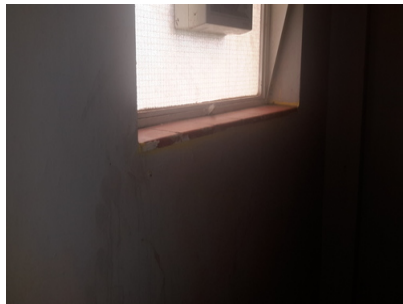
John Frost School Building 1	0	056/WC	Damp proof course to wall cavity under windows	255768-52	Asbestos-containing bituminous product	Chrysotile		1 Sqm.	ERROR	Remove

Building: John Frost School Building 1			Level: 0		Location: 056/WC						
Item / Product Examined	Material Description	Sampling Strategy	Sample No.	Extent	Product Score	Material Condition	Surface Treatment	Fibre Id.	Material Score	Accessibility Score	Risk Level Assessment
Beams	Concrete										
Damp proof course to wall cavity under windows	Asbestos-containing bituminous product	Cross Reference	255768-52	1 Sqm.	1	1		Chrysotile		1

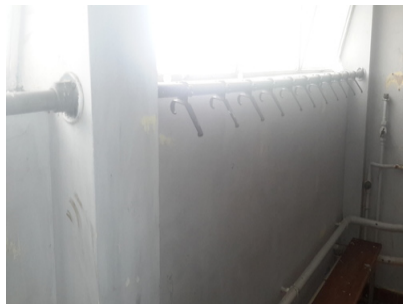
John Frost School Building 1	0	057/ changing room	Damp proof course to wall cavity under windows	255768-52	Asbestos-containing bituminous product	Chrysotile		3 Sqm.	ERROR	Remove

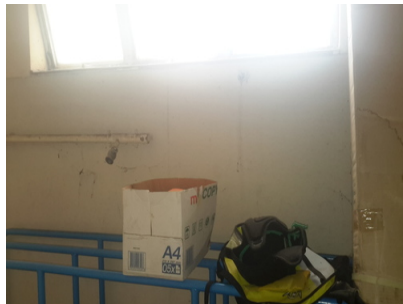
John Frost School Building 1	0	058/ showers	Damp proof course to wall cavity under windows	255768-52	Asbestos-containing bituminous product	Chrysotile		3 Sqm.	ERROR	Remove

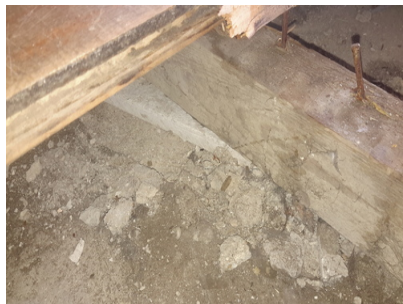
John Frost School Building 1	0	060/gym	Spring floor frame packers	255768-109	Asbestos-containing insulating board	Chrysotile, Amosite	8	Throughout Location	R2	Remove

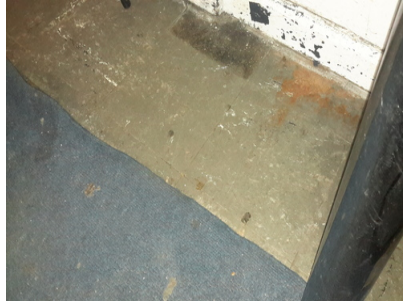
John Frost School Building 1	1	001/classroom	Floor tiles	255768-29	Asbestos-containing floor tile with bitumen adhesive	Chrysotile	3	30 Sqm.	R3	Remove

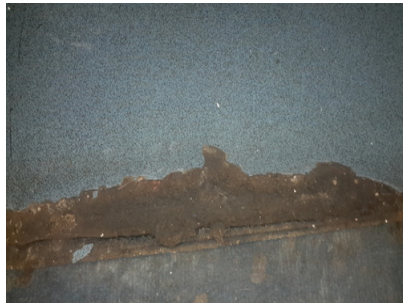
John Frost School Building 1	1	002/lobby	Floor bitumen	255768-31	Asbestos-containing bitumen adhesive	Chrysotile	3	5 Sqm.	R3	Remove

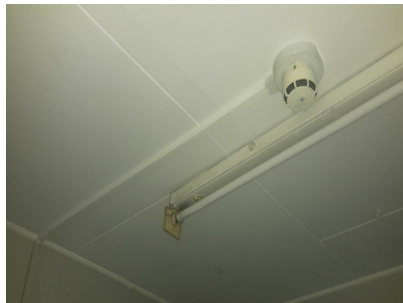
John Frost School Building 1	1	002/lobby	Ceiling	255768-28	Asbestos-containing insulating board	Amosite, Chrysotile	5	5 Sqm.	R3	Remove

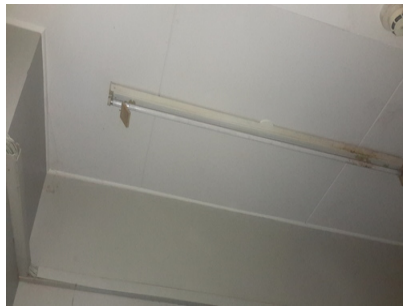
Building	Level	Location	Item / Product Examined	Sample No.	Material Description	Fibre Type	Material Score	Extent	Risk Level Assessment	Initial Control Recommendation	Photograph
John Frost School Building 1	1	003/landing	Ceiling	255768-28	Asbestos-containing insulating board	Amosite, Chrysotile	5	12 Sqm.	R3	Remove

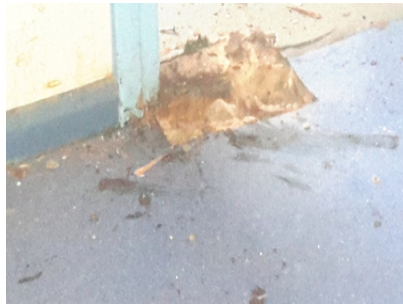
John Frost School Building 1	1	003/landing	Floor bitumen	255768-31	Asbestos-containing bitumen adhesive	Chrysotile	3	4 Sqm.	R3	Remove

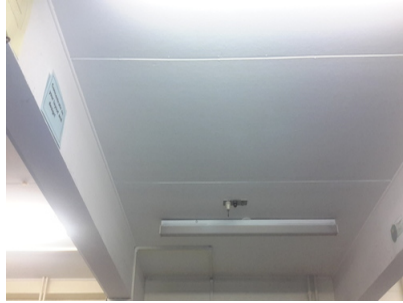
John Frost School Building 1	1	004/classroom	Ceiling	255768-28	Asbestos-containing insulating board	Amosite, Chrysotile	5	60 Sqm.	R3	Remove

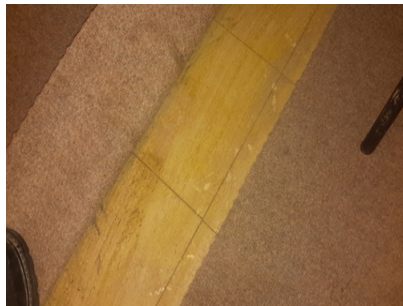
Building	Level	Location	Item / Product Examined	Sample No.	Material Description	Fibre Type	Material Score	Extent	Risk Level Assessment	Initial Control Recommendation	Photograph
John Frost School Building 1	1	004/ classroom	Floor tiles	255768-32	Asbestos-containing floor tile with bitumen adhesive	Chrysotile	3	60 Sqm.	R3	Remove

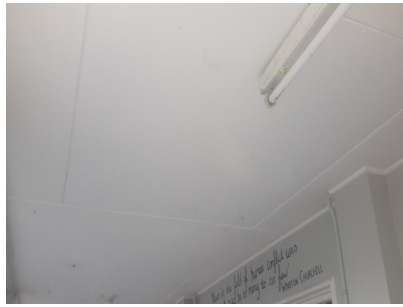
John Frost School Building 1	1	005/ corridor	Ceiling	255768-28	Asbestos-containing insulating board	Amosite, Chrysotile	5	30 Sqm.	R3	Remove

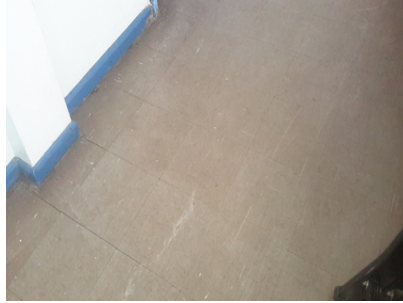
John Frost School Building 1	1	005/ corridor	Floor tiles	255768-33	Asbestos-containing floor tile with bitumen adhesive	Chrysotile	3	30 Sqm.	R3	Remove

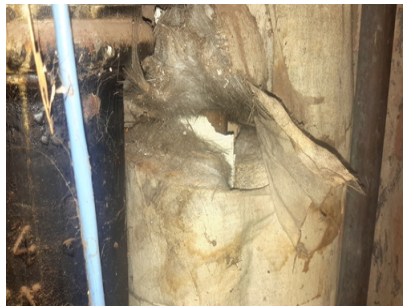
Building	Level	Location	Item / Product Examined	Sample No.	Material Description	Fibre Type	Material Score	Extent	Risk Level Assessment	Initial Control Recommendation	Photograph
John Frost School Building 1	1	006/classroom	Vertical boxing pipework insulation lining	255768-35	Asbestos-containing paper	Chrysotile	8	6 Lm.	R2	Remove

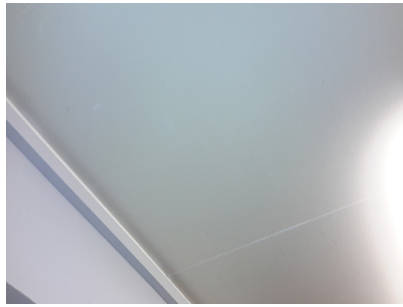
John Frost School Building 1	1	006/classroom	Ceiling	255768-28	Asbestos-containing insulating board	Amosite, Chrysotile	5	60 Sqm.	R3	Remove

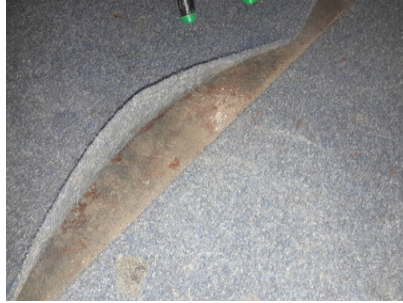
John Frost School Building 1	1	006/classroom	Floor tiles	255768-34	Asbestos-containing floor tile with bitumen adhesive	Chrysotile	3	60 Sqm.	R3	Remove

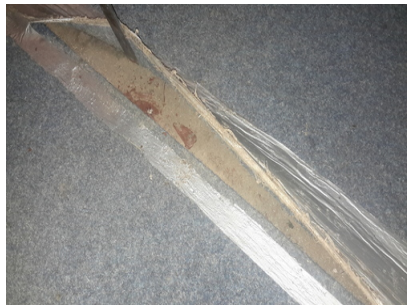
John Frost School Building 1	1	008/ classroom	Floor tiles	255768-34	Asbestos-containing floor tile with bitumen adhesive	Chrysotile	3	60 Sqm.	R3	Remove

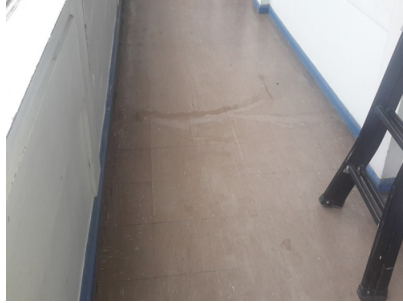
John Frost School Building 1	1	009/corridor	Floor tiles	255768-33	Asbestos-containing floor tile with bitumen adhesive	Chrysotile	3	30 Sqm.	R3	Remove

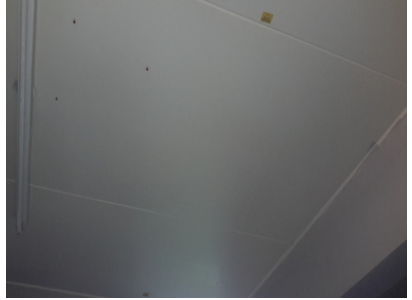
John Frost School Building 1	1	011/ classroom	Ceiling	255768-38	Asbestos-containing insulating board	Amosite, Chrysotile	5	60 Sqm.	R3	Remove

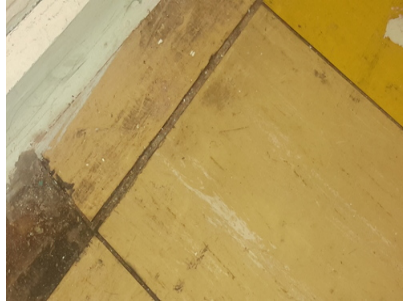
John Frost School Building 1	1	012/ classroom	Floor covering	255768-40	Asbestos-containing linoleum	Chrysotile	4	6 Sqm.	R3	Remove

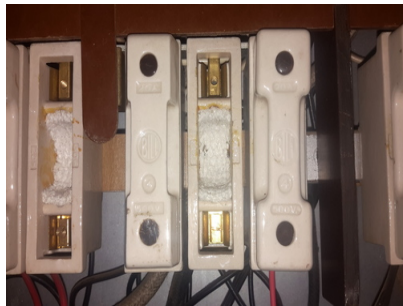
Building	Level	Location	Item / Product Examined	Sample No.	Material Description	Fibre Type	Material Score	Extent	Risk Level Assessment	Initial Control Recommendation	Photograph
John Frost School Building 1	1	012/classroom	Flashguards to fusebox	255768-39	Asbestos-containing woven product	Chrysotile	6	18 No.	R3	Remove

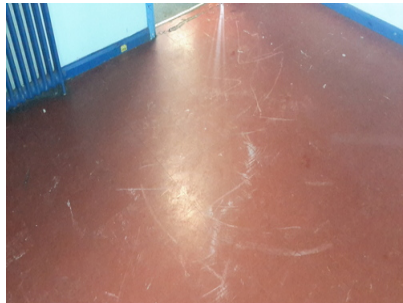
John Frost School Building 1	1	013/lobby	Floor tiles	255768-42	Asbestos-containing floor tile with bitumen adhesive	Chrysotile	3	6 Sqm.	R3	Remove

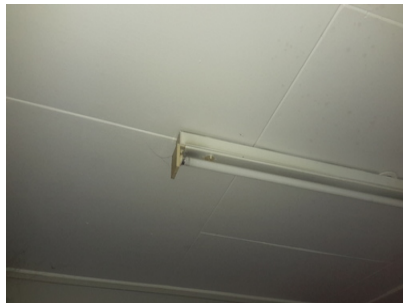
John Frost School Building 1	1	013/lobby	Ceiling	255768-38	Asbestos-containing insulating board	Amosite, Chrysotile	5	6 Sqm.	R3	Remove

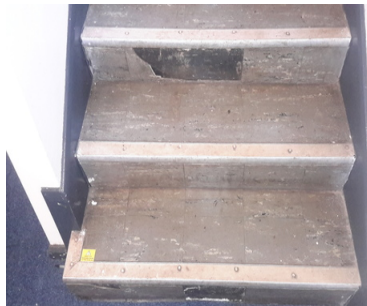
Building	Level	Location	Item / Product Examined	Sample No.	Material Description	Fibre Type	Material Score	Extent	Risk Level Assessment	Initial Control Recommendation	Photograph
John Frost School Building 1	1	015/ classroom	Stair tread tiles	255768-43	Asbestos-containing floor tile with bitumen adhesive	Chrysotile	4	2 Sqm.	R3	Remove

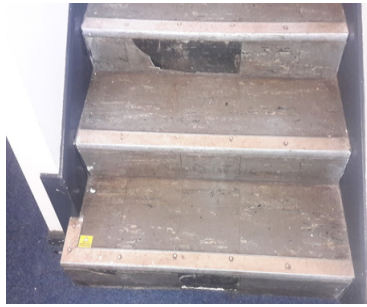
John Frost School Building 1	1	015/ classroom	Stair tread nosing	255768-44	Asbestos-containing thermoplastic	Chrysotile	3	5 Lm.	R3	Remove

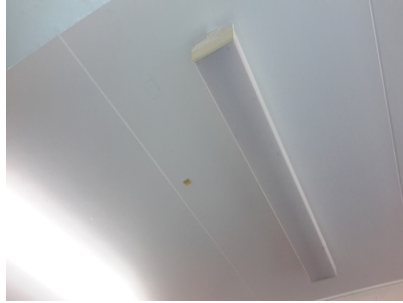
John Frost School Building 1	1	015/ classroom	Ceiling	255768-38	Asbestos-containing insulating board	Amosite, Chrysotile	5	60 Sqm.	R3	Remove

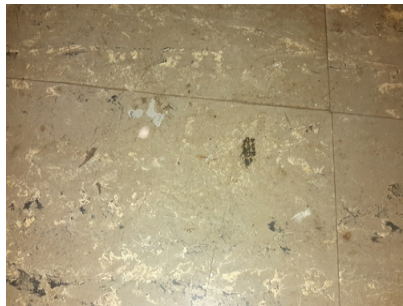
Building	Level	Location	Item / Product Examined	Sample No.	Material Description	Fibre Type	Material Score	Extent	Risk Level Assessment	Initial Control Recommendation	Photograph
John Frost School Building 1	1	015/classroom	Floor tiles	255768-43	Asbestos-containing floor tile with bitumen adhesive	Chrysotile	3	60 Sqm.	R3	Remove

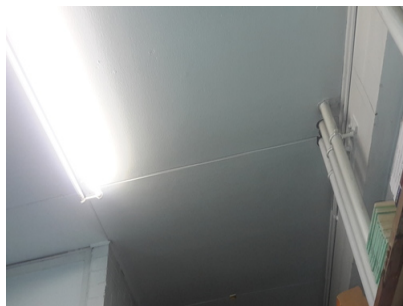
John Frost School Building 1	1	016/store	Ceiling	255768-28	Asbestos-containing insulating board	Amosite, Chrysotile	5	8 Sqm.	R3	Remove

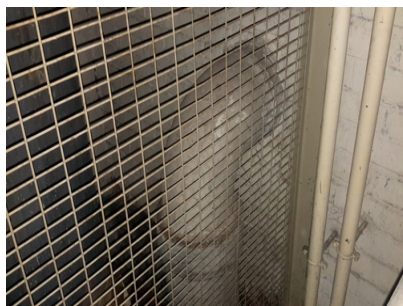
John Frost School Building 1	1	016/store	Pipework behind wall boarding		Asbestos-containing cement	Strongly Presume Chrysotile	3	3 Lm.	R3	Remove

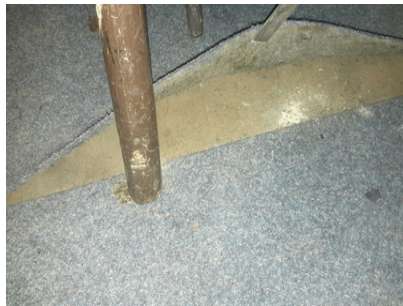
Building	Level	Location	Item / Product Examined	Sample No.	Material Description	Fibre Type	Material Score	Extent	Risk Level Assessment	Initial Control Recommendation	Photograph
John Frost School Building 1	1	018/ classroom	Floor tiles	255768-45	Asbestos-containing floor tile with bitumen adhesive	Chrysotile	3	60 Sqm.	R3	Remove

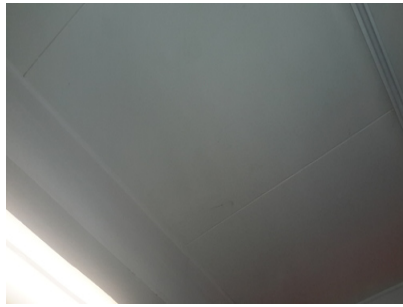
John Frost School Building 1	1	018/ classroom	Ceiling	255768-38	Asbestos-containing insulating board	Amosite, Chrysotile	5	60 Sqm.	R3	Remove

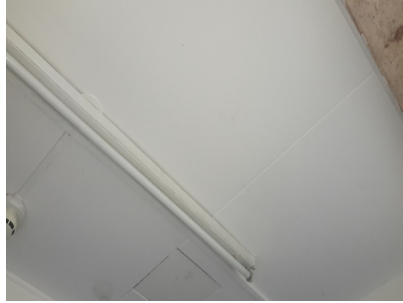
John Frost School Building 1	1	019/ landing	Ceiling	255768-28	Asbestos-containing insulating board	Amosite, Chrysotile	5	14 Sqm.	R3	Remove

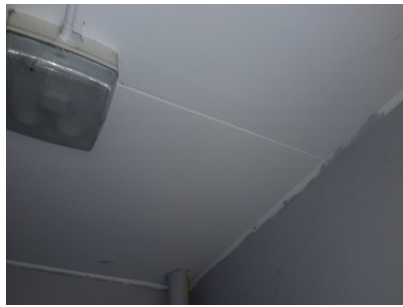
John Frost School Building 1	1	022/WC	Ceiling	255768-68	Asbestos-containing insulating board	Amosite, Chrysotile	5	4 Sqm.	R3	Remove

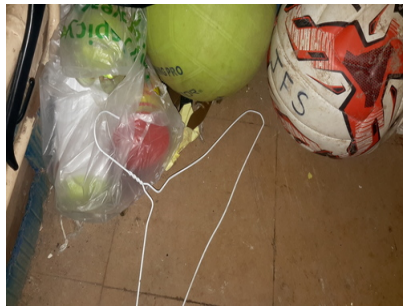
Building	Level	Location	Item / Product Examined	Sample No.	Material Description	Fibre Type	Material Score	Extent	Risk Level Assessment	Initial Control Recommendation	Photograph
John Frost School Building 1	1	023/WC	Floor tiles	255768-70	Asbestos-containing floor tile with bitumen adhesive	Chrysotile	3	2 Sqm.	R3	Remove

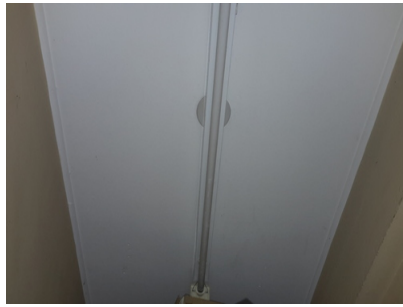
John Frost School Building 1	1	023/WC	Ceiling	255768-68	Asbestos-containing insulating board	Amosite, Chrysotile	5	2 Sqm.	R3	Remove

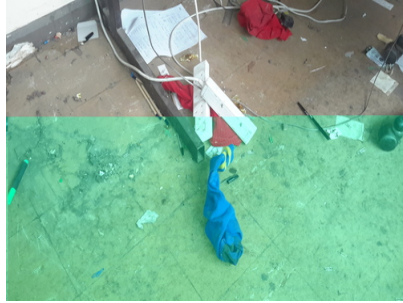
John Frost School Building 1	1	024/office	Floor tiles	255768-70	Asbestos-containing floor tile with bitumen adhesive	Chrysotile	4	4 Sqm.	R3	Remove

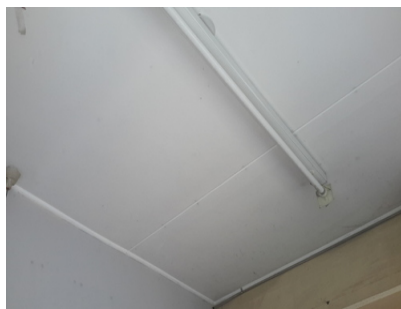
Building	Level	Location	Item / Product Examined	Sample No.	Material Description	Fibre Type	Material Score	Extent	Risk Level Assessment	Initial Control Recommendation	Photograph
John Frost School Building 1	1	024/office	Ceiling	255768-68	Asbestos-containing insulating board	Amosite, Chrysotile	5	4 Sqm.	R3	Remove

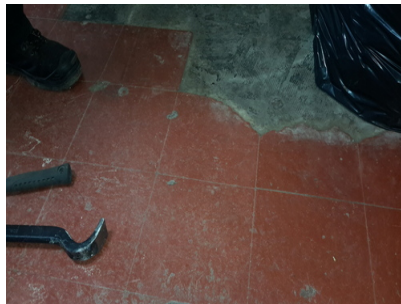
John Frost School Building 1	1	025/landing	Floor tiles	255768-71	Asbestos-containing floor tile with bitumen adhesive	Chrysotile	4	6 Sqm.	R3	Remove

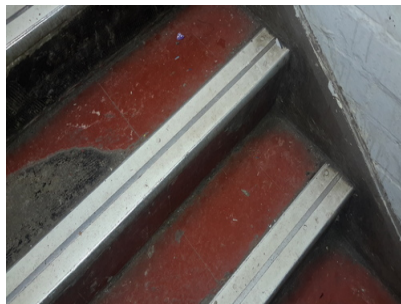
John Frost School Building 1	1	025/landing	Stair tread nosing	255768-72	Asbestos-containing thermoplastic	Chrysotile	3	3 No.	R3	Remove

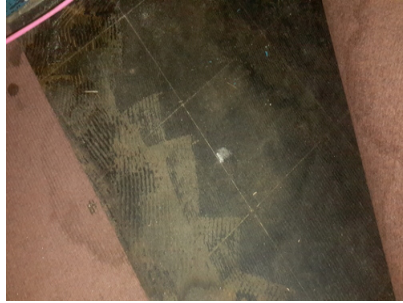
John Frost School Building 1	2	001/classroom	Floor bitumen	255768-2	Asbestos-containing bitumen adhesive	Chrysotile	3	30 Sqm.	R3	Remove

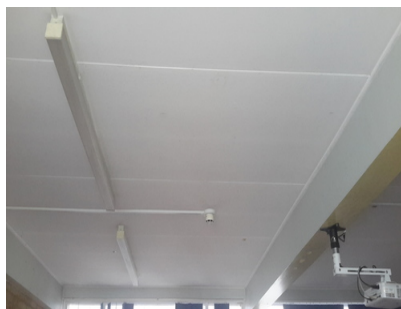
Building	Level	Location	Item / Product Examined	Sample No.	Material Description	Fibre Type	Material Score	Extent	Risk Level Assessment	Initial Control Recommendation	Photograph
John Frost School Building 1	2	001/ classroom	Ceiling	255768-1	Asbestos-containing insulating board	Amosite, Chrysotile	5	30 Sqm.	R3	Remove

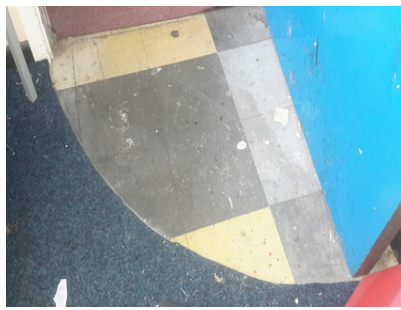
John Frost School Building 1	2	002/ classroom store	Floor tiles	255768-4	Asbestos-containing floor tile with bitumen adhesive	Chrysotile	3	6 Sqm.	R3	Remove

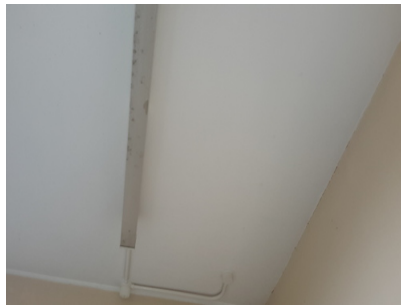
John Frost School Building 1	2	002/ classroom store	Ceiling	255768-1	Asbestos-containing insulating board	Amosite, Chrysotile	5	6 Sqm.	R3	Remove

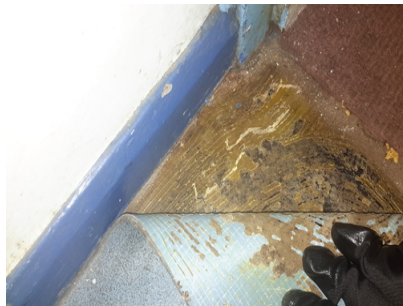
Building	Level	Location	Item / Product Examined	Sample No.	Material Description	Fibre Type	Material Score	Extent	Risk Level Assessment	Initial Control Recommendation	Photograph
John Frost School Building 1	2	003/lobby	Floor bitumen	255768-2	Asbestos-containing bitumen adhesive	Chrysotile	3	6 Sqm.	R3	Remove

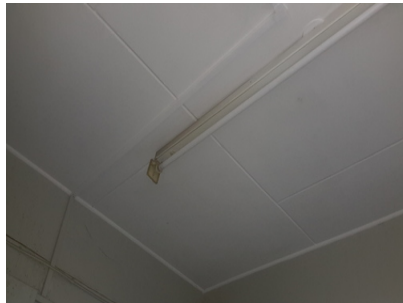
John Frost School Building 1	2	003/lobby	Ceiling	255768-1	Asbestos-containing insulating board	Amosite, Chrysotile	5	6 Sqm.	R3	Remove

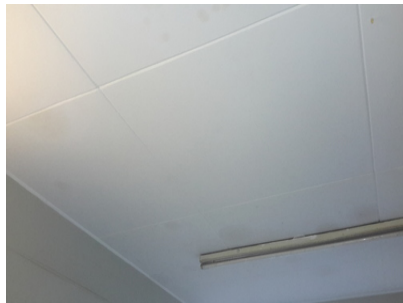
John Frost School Building 1	2	004/landing	Ceiling	255768-1	Asbestos-containing insulating board	Amosite, Chrysotile	5	12 Sqm.	R3	Remove

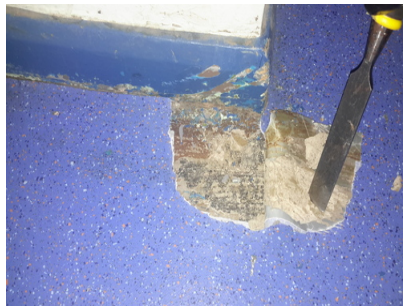
Building	Level	Location	Item / Product Examined	Sample No.	Material Description	Fibre Type	Material Score	Extent	Risk Level Assessment	Initial Control Recommendation	Photograph
John Frost School Building 1	2	004/landing	Floor bitumen	255768-2	Asbestos-containing bitumen adhesive	Chrysotile	3	4 Sqm.	R3	Remove

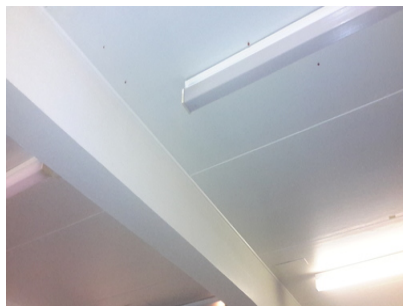
John Frost School Building 1	2	005/classroom	Ceiling	255768-1	Asbestos-containing insulating board	Amosite, Chrysotile	5	60 Sqm.	R3	Remove

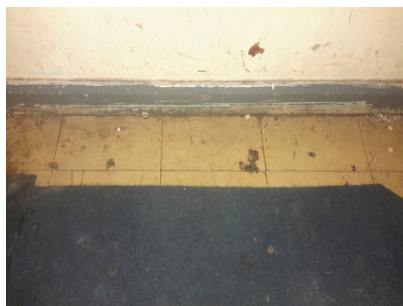
John Frost School Building 1	2	005/classroom	Floor tiles	255768-5	Asbestos-containing floor tile with bitumen adhesive	Chrysotile	3	60 Sqm.	R3	Remove

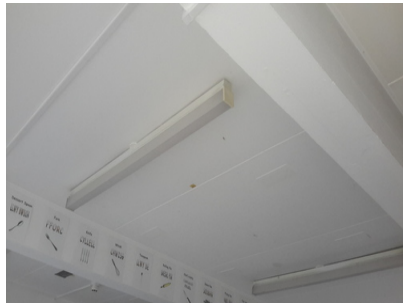
John Frost School Building 1	2	006/ classroom	Ceiling	255768-1	Asbestos-containing insulating board	Amosite, Chrysotile	5	60 Sqm.	R3	Remove

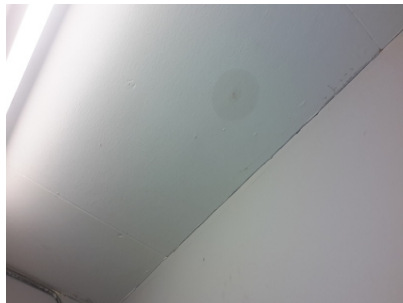
John Frost School Building 1	2	007/ classroom store	Ceiling	255768-1	Asbestos-containing insulating board	Amosite, Chrysotile	5	5 Sqm.	R3	Remove

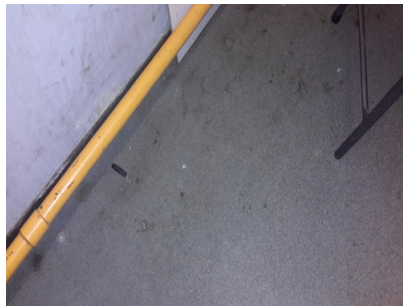
Building	Level	Location	Item / Product Examined	Sample No.	Material Description	Fibre Type	Material Score	Extent	Risk Level Assessment	Initial Control Recommendation	Photograph
John Frost School Building 1	2	007/ classroom store	Floor bitumen	255768-2	Asbestos-containing bitumen adhesive	Chrysotile	3	5 Sqm.	R3	Remove

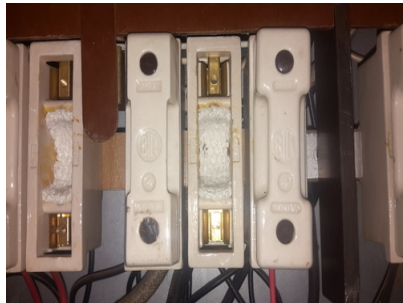
John Frost School Building 1	2	008/ classroom	Flashguards to fuse box	255768-39	Asbestos-containing woven product	Chrysotile	6	18 No.	R3	Remove

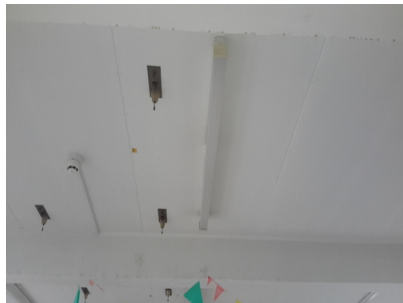
John Frost School Building 1	2	008/ classroom	Ceiling	255768-9	Asbestos-containing insulating board	Amosite, Chrysotile	5	60 Sqm.	R3	Remove

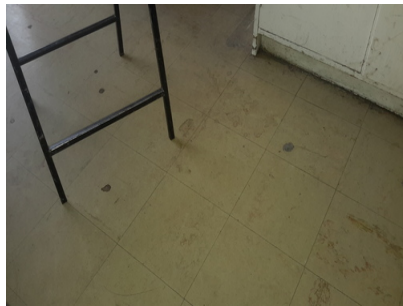
Building	Level	Location	Item / Product Examined	Sample No.	Material Description	Fibre Type	Material Score	Extent	Risk Level Assessment	Initial Control Recommendation	Photograph
John Frost School Building 1	2	008/classroom	Floor tiles	255768-10	Asbestos-containing floor tile with bitumen adhesive	Chrysotile	3	60 Sqm.	R3	Remove

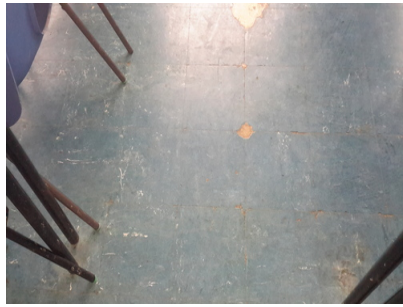
John Frost School Building 1	2	009/classroom	Floor tiles	255768-12	Asbestos-containing floor tile with bitumen adhesive	Chrysotile	3	60 Sqm.	R3	Remove

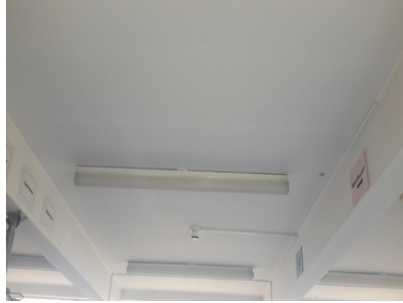
John Frost School Building 1	2	009/classroom	Ceiling	255768-9	Asbestos-containing insulating board	Amosite, Chrysotile	5	60 Sqm.	R3	Remove
