Asbestos Pre-Demolition Survey Report

Job Ref No: **255768**, Account Ref No: **1095**, Contract Ref No: **33744**

John Frost School Lighthouse Rd, Duffryn, Newport NP10 8YD

Title: Demolition survey of John Frost School

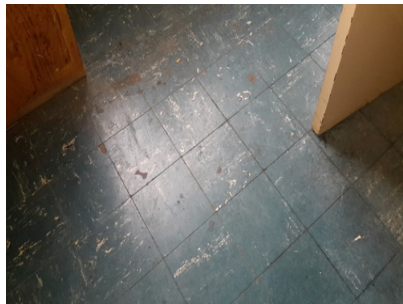
John Frost School Building 1	2	010/ classroom store	Floor tiles	255768-12	Asbestos-containing floor tile with bitumen adhesive	Chrysotile	3	6 Sqm.	R3	Remove

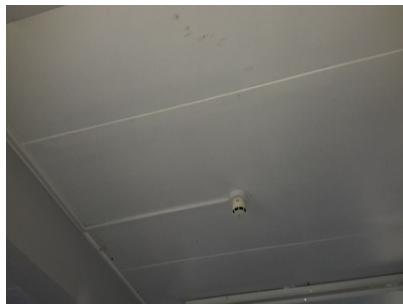
John Frost School Building 1	2	011/ classroom	Ceiling	255768-9	Asbestos-containing insulating board	Amosite, Chrysotile	5	60 Sqm.	R3	Remove

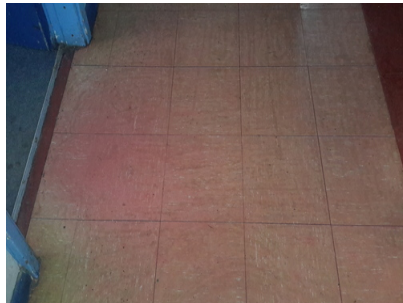
John Frost School Building 1	2	014/lobby	Large floor tiles	255768-19	Asbestos-containing floor tile with bitumen adhesive	Chrysotile	3	3 Sqm.	R3	Remove

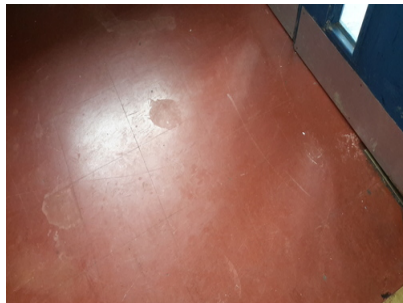
John Frost School Building 1	2	014/lobby	Small floor tiles	255768-18	Asbestos-containing floor tile with bitumen adhesive	Chrysotile	3	3 Sqm.	R3	Remove

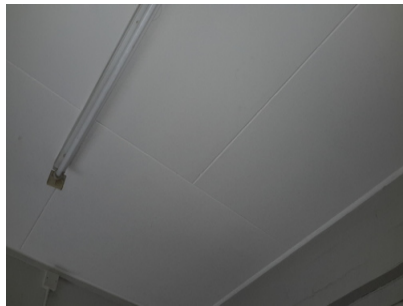
Building	Level	Location	Item / Product Examined	Sample No.	Material Description	Fibre Type	Material Score	Extent	Risk Level Assessment	Initial Control Recommendation	Photograph
John Frost School Building 1	2	014/lobby	Ceiling	255768-9	Asbestos-containing insulating board	Amosite, Chrysotile	5	8 Sqm.	R3	Remove

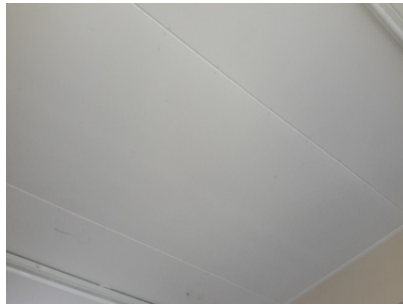
John Frost School Building 1	2	016/classroom	Ceiling	255768-20	Asbestos-containing insulating board	Amosite, Chrysotile	5	40 Sqm.	R3	Remove

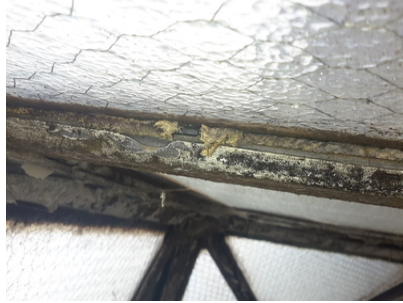
John Frost School Building 1	2	016/classroom	Skylight rope seal	255768-21	Asbestos-containing woven product	Chrysotile	6	10 Lm.	R3	Remove

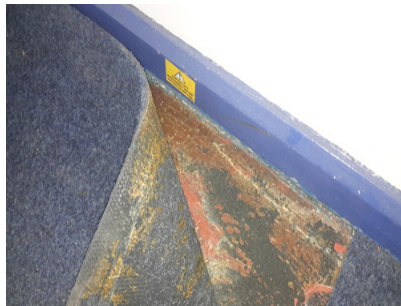
Building	Level	Location	Item / Product Examined	Sample No.	Material Description	Fibre Type	Material Score	Extent	Risk Level Assessment	Initial Control Recommendation	Photograph
John Frost School Building 1	2	016/ classroom	Small floor tiles	255768-18	Asbestos-containing floor tile with bitumen adhesive	Chrysotile	3	3 Sqm.	R3	Remove

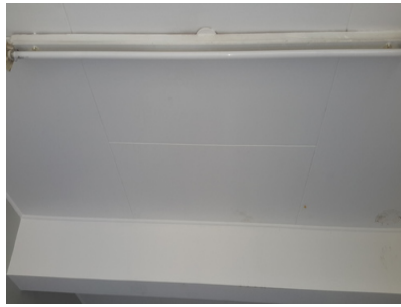
John Frost School Building 1	2	017/ landing	Ceiling	255768-20	Asbestos-containing insulating board	Amosite, Chrysotile	5	14 Sqm.	R3	Remove

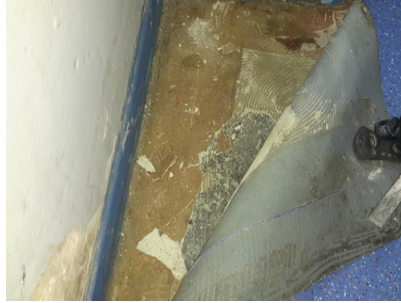
John Frost School Building 1	2	017/ landing	Floor bitumen	255768-2	Asbestos-containing bitumen adhesive	Chrysotile	3	3 Sqm.	R3	Remove

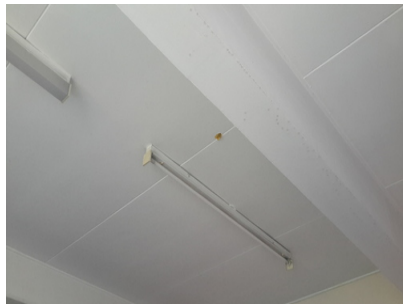
John Frost School Building 1	2	018/ classroom	Ceiling	255768-20	Asbestos-containing insulating board	Amosite, Chrysotile	5	40 Sqm.	R3	Remove

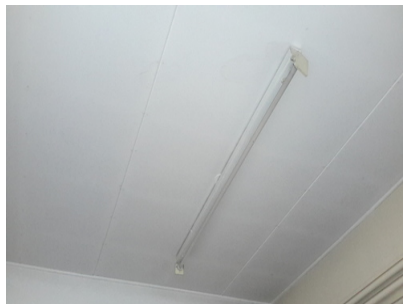
John Frost School Building 1	2	020/ classroom	Ceiling	255768-20	Asbestos-containing insulating board	Amosite, Chrysotile	5	10 Sqm.	R3	Remove

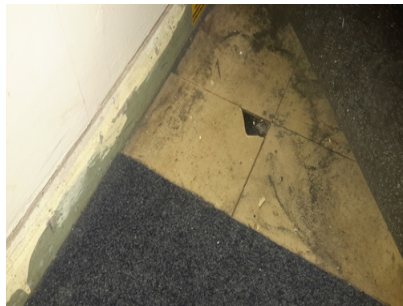
Building	Level	Location	Item / Product Examined	Sample No.	Material Description	Fibre Type	Material Score	Extent	Risk Level Assessment	Initial Control Recommendation	Photograph
John Frost School Building 1	2	020/classroom	Floor tiles	255768-23	Asbestos-containing floor tile with bitumen adhesive	Chrysotile	3	10 Sqm.	R3	Remove

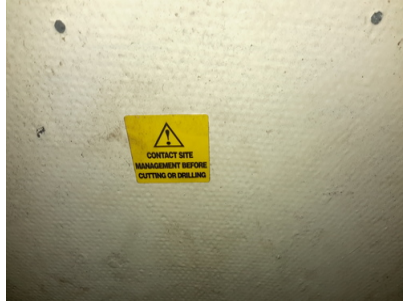
John Frost School Building 1	2	021/store	Ceiling hatch panel	255768-25	Asbestos-containing cement	Chrysotile	4	0.5 Sqm.	R3	Remove

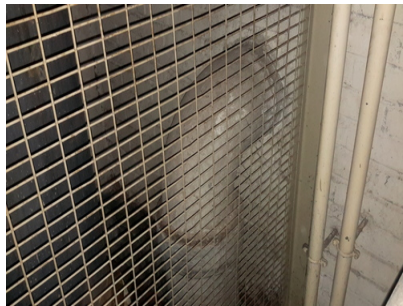
Building	Level	Location	Item / Product Examined	Sample No.	Material Description	Fibre Type	Material Score	Extent	Risk Level Assessment	Initial Control Recommendation	Photograph
John Frost School Building 1	3	001/tank room	Pipework behind caging		Asbestos-containing cement	Strongly Presume Chrysotile	4	1 Lm.	R3	Remove

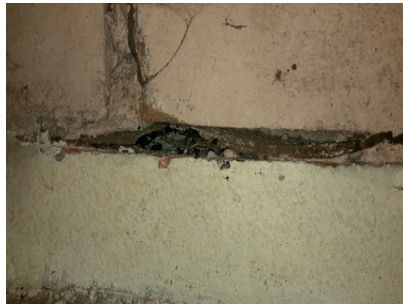
John Frost School Building 1	3	001/tank room	Damp proof course to lower level of wall	255768-27	Asbestos-containing bituminous product	Chrysotile	3	12 Lm.	R3	Remove

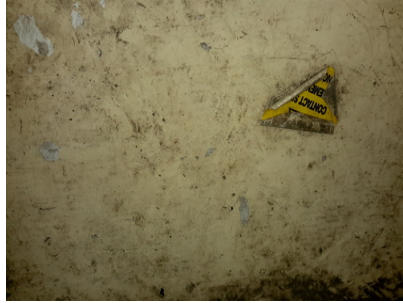
John Frost School Building 1	3	001/tank room	Floor hatch	255768-25	Asbestos-containing cement	Chrysotile	4	0.5 Sqm.	R3	Remove

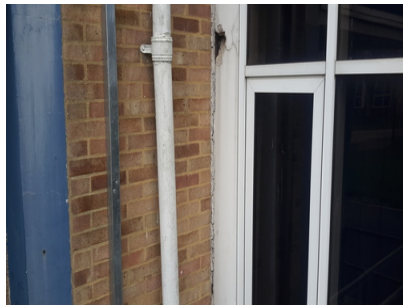
John Frost School Building 1	9	999/externals	Expansion joint mastic	255768-58	Asbestos-containing mastic	Chrysotile	3	40 Lm.	R3	Remove

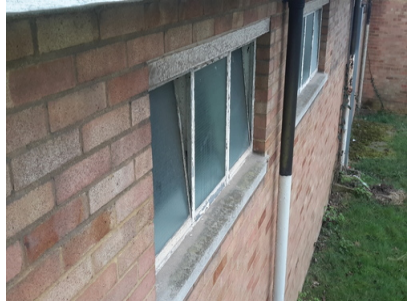
John Frost School Building 1	9	999/externals	Old window mastic	255768-62	Asbestos-containing mastic	Chrysotile	4	Throughout Location	R3	Remove

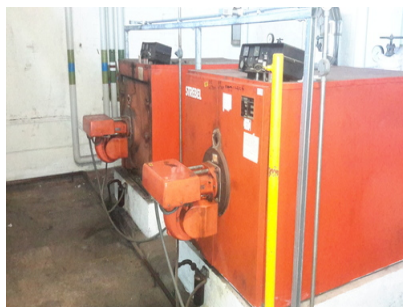
Building	Level	Location	Item / Product Examined	Accessibility	Surveyor Additional Comments At Time Of Survey	Photograph
John Frost School Building 1	0	041/plant room	Boilers	Limited Access	Live service supply

💬 Boilers not isolated		
John Frost School Building 1	0	041/plant room	Electrics	No Access	Live service supply

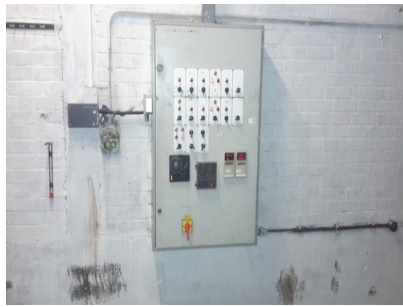
💬 Not isolated		
John Frost School Building 1	0	060/gym	Concrete floor void	No Access	Physically restricted space

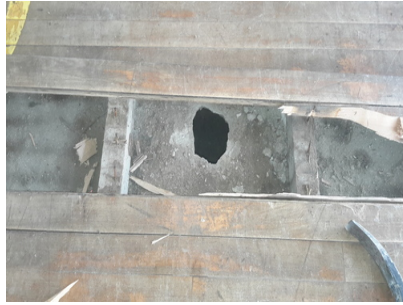
💬 No access

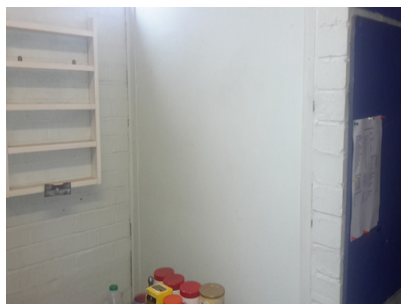
💬 No access to ceiling void hatches with scaffold, ceiling height approximately 5.5-6m		
John Frost School Building 1	1	016/store	Cavity behind wall boarding	Limited Access	Suspect ACM present

💬 No access behind boarding		
John Frost School Building 1	2	006/classroom	Electrics	Limited Access	Live service supply

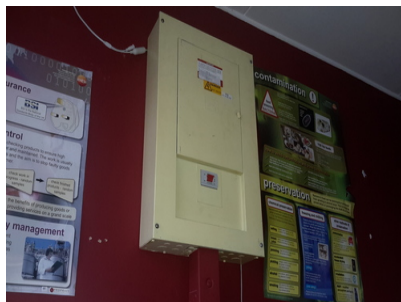
💬 No access without isolating power		
John Frost School Building 1	2	006/classroom	Vertical boxing cavity	Limited Access	Suspect ACM present

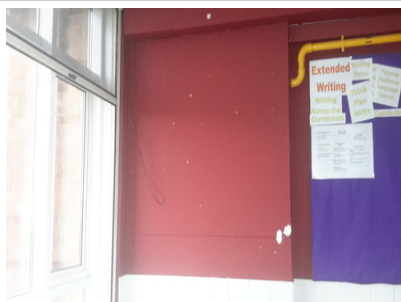
💬 No access without causing damage to suspect ACM

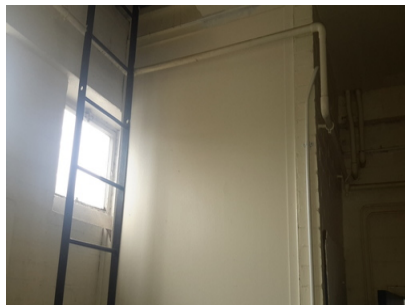
Building	Level	Location	Item / Product Examined	Accessibility	Surveyor Additional Comments At Time Of Survey	Photograph
John Frost School Building 1	2	021/store	Cavity behind wall boarding	Limited Access	Suspect ACM present

Unable to go past suspect ACM
